Safety Inspection Report

Annual Inspection

Church View Play Area

Stibbard Parish Council

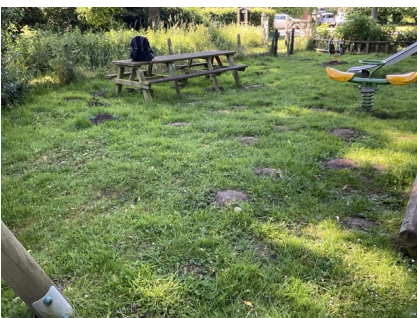
Mole hills present.

Eliminate.

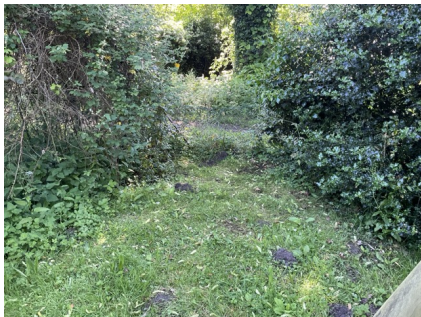
Monitor.

Monitor damage to the fence. Repair as required.

Read the notes for further action.

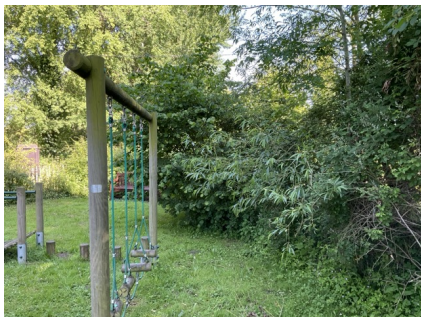
Encroaching vegetation or trees.

Cut back vegetation and maintain hedge.

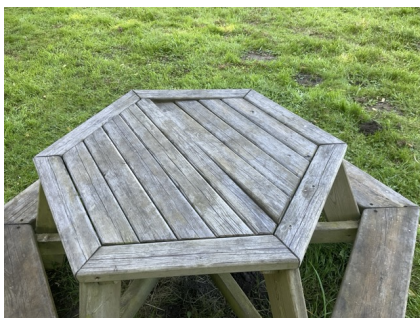
Minor repairs are needed.

Repair.

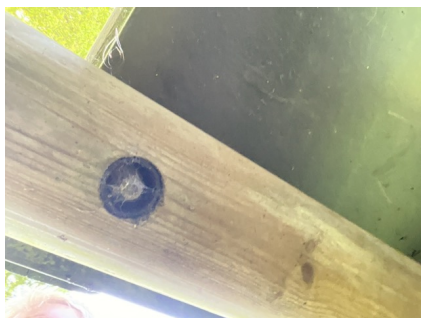
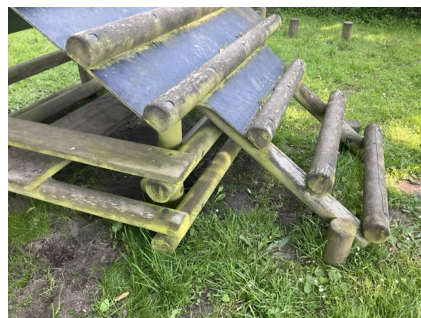
Cap missing.

Replace.

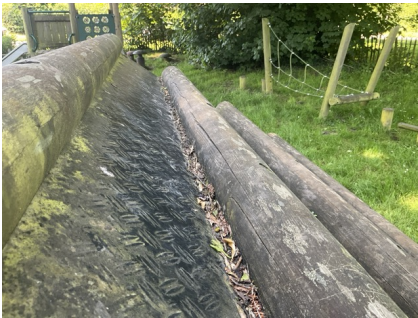
There are natural splits / shakes in the timbers.

Shakes vary. Monitor and consult manufacturer if dimensions exceed 8 mm at sections used to grip / grasp., DO NOT fill shakes. Monitor and sand back any splintered edges as required.

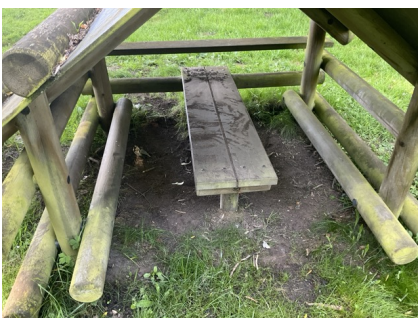
Worn ground areas.

Consider installing grass mats to help with wear.

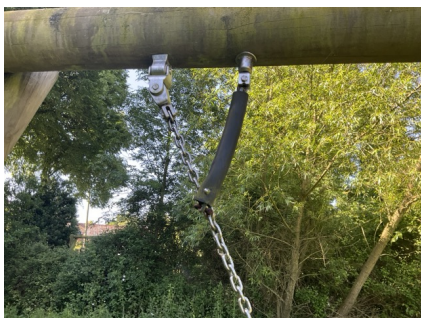
Chain covers prevent a thorough inspection of all chain links.

Remove chain covers to inspect according to manufacturer's instructions.

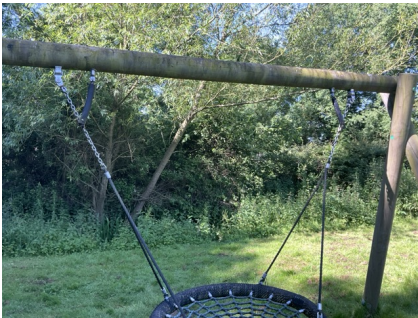
The supporting components should be dismantled and inspected according to the manufacturer's instructions. This will need doing on a regular basis, as defined by the manufacturer. This can lead to a high risk if no action is taken.

Dismantle and inspect according to manufacturer's instructions.

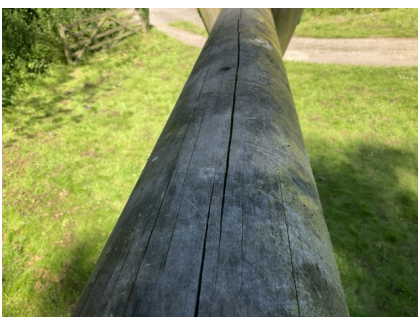
There are natural splits / shakes in the timbers.

Monitor for decay forming within the shakes on the crossbar.

Monitor and sand back any splintered edges as required.

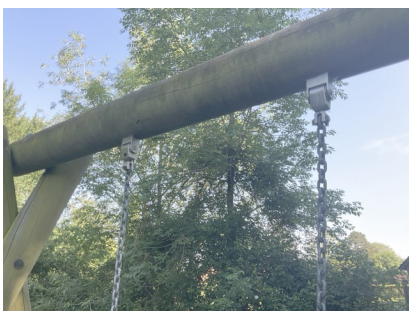
Bolt(s) loose.

Swing hanger bolts are loose on the crossbar.

Tighten.

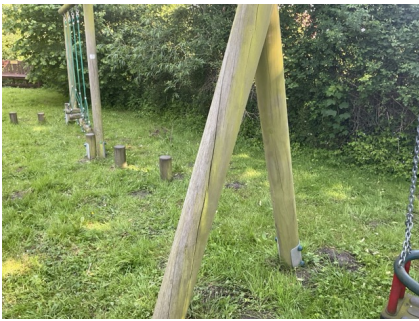
There are natural splits / shakes in the timbers.

Monitor and sand back any splintered edges as required.

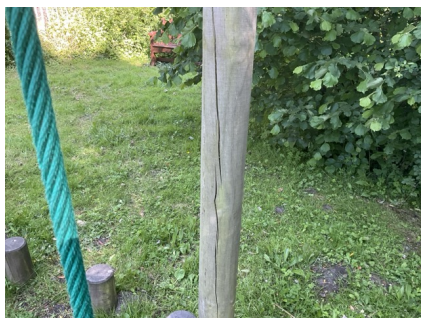
There are natural splits / shakes in the timbers.

Monitor and sand back any splintered edges as required., There are shakes running through fixing points. Ensure the fixings are fully secure on regular basis.

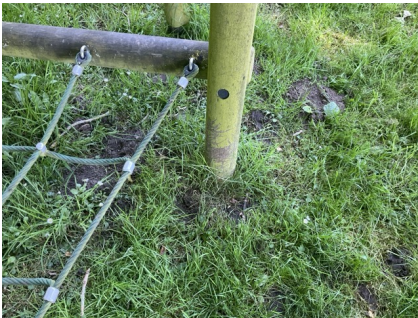
Strimmer damage is present on posts, allowing water to enter and timbers to soften. It can also remove the protective envelope around the timber. Prevent further damage and check timbers for decay throughout the year.

Prevent further damage.

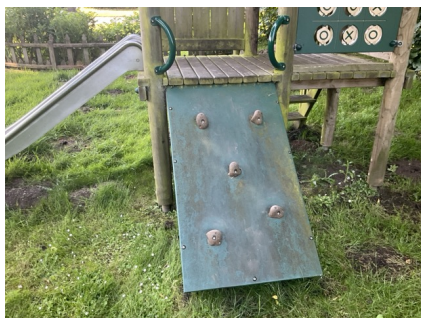
The equipment is dirty or algae covered.

Clean off.

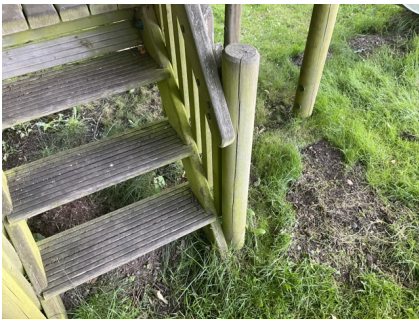
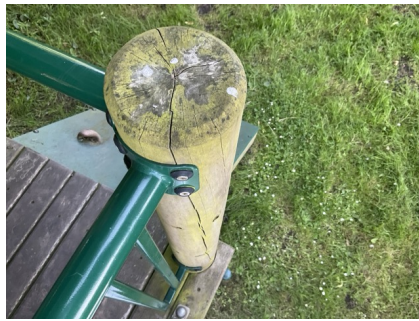
There are natural splits / shakes in the timbers.

Monitor and sand back any splintered edges as required., There are shakes running through fixing points. Ensure the fixings are fully secure on regular basis.

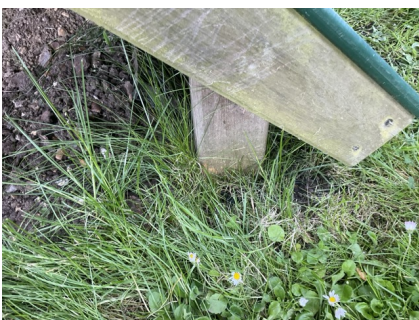
Strimmer damage is present on posts, allowing water to enter and timbers to soften. It can also remove the protective envelope around the timber. Prevent further damage and check timbers for decay throughout the year.

Prevent further damage.

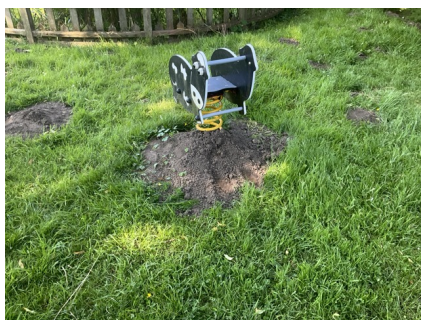
Mole hills present.

Eliminate.

Level of ground and repair.

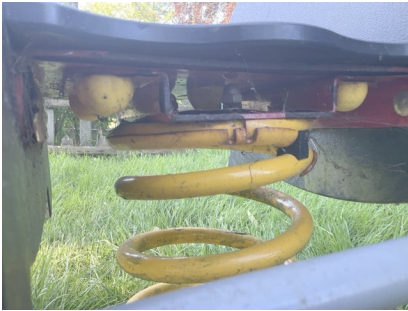
Paintwork is in poor condition.

De-scale back to good base material and coat with lead free paint, using appropriate precautions. Repairs may be necessary where corrosion is severe.

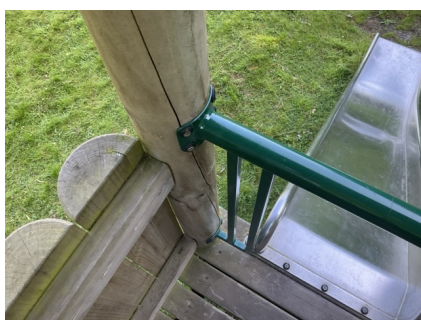
There are natural splits / shakes in the timbers.

Monitor and sand back any splintered edges as required., There are shakes running through fixing points. Ensure the fixings are fully secure on regular basis.

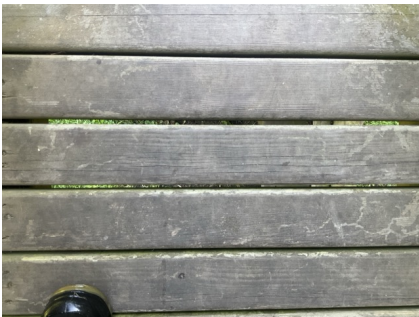
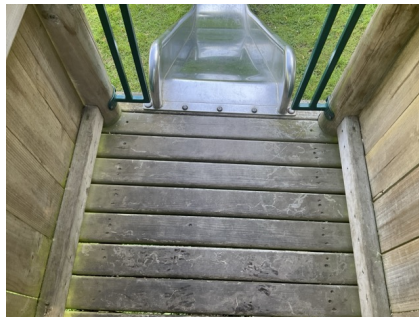
The item is not compliant with the requirements of the relevant standards. The surfacing meets with the requirements of the relevant standards.

Finger entrapment.

Finger entrapment in the floor panel at the top of the slide.

Eliminate the entrapment.
